Subject: Velocity Body Fan Problem

Number: SRV0018

Applicability: Velocity 918HP

Date: 3/2/2006

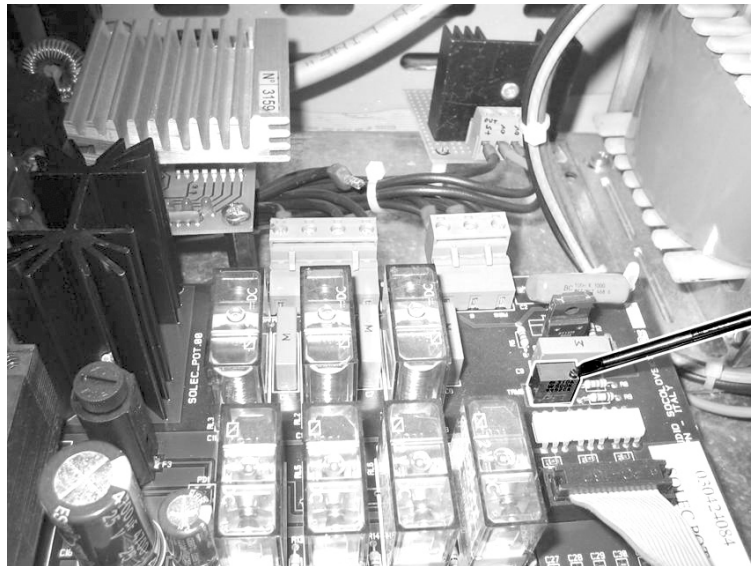
Symptoms: Body fan will operate at full speed (level 4), but turns off at other levels.

Explanation: Trimmer capacitor on main circuit board needs to be adjusted.

- Solution:**
1. The body fan is located in the foot end of the Velocity. Remove the upper cover panel to find the fan.
 2. Open the front ballast/electrical compartment and locate the circuit board in the picture below. Locate the trimmer capacitor as indicated.
 3. Start a session and wait 45 seconds for the body fan to energize.
 4. Attach a voltmeter to the blue and black terminals on one of the body fans (there are three).
 5. Press the "Air –" button on the control panel to reduce the fan speed to level 3.
 6. Using a small, flat-bladed screwdriver, turn the trimmer capacitor clockwise until the voltmeter (still on the fan) reads 180V.
 7. Levels 1 and 2 will automatically set once this adjustment is made.
