Subject: Quench Arc application

Number: SRV0031

Applicability: SS755, 755 ELITE, SolarForce® 648
Any other units exhibiting these symptoms

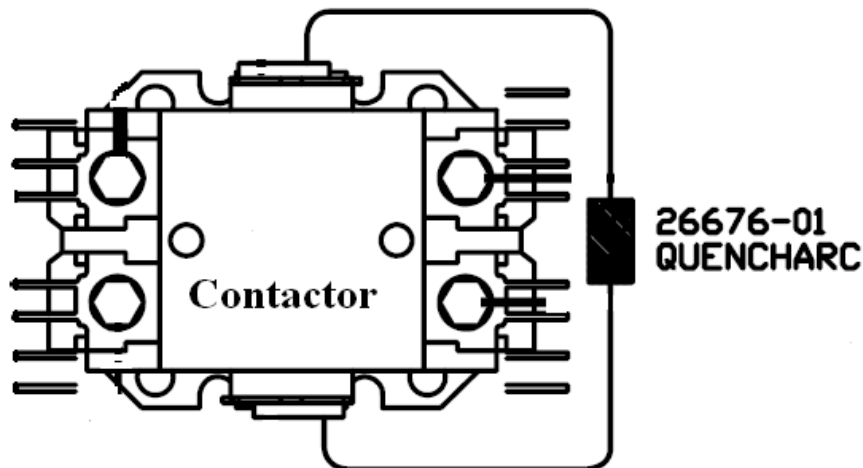
Symptoms: Unit is resetting itself during session

Unit is not displaying clean room indicator; timer automatically clearing clean room indicator

Unit display goes out, unrelated to heat

Explanation: Timers are designed to reset if electronic noise level disrupts timer operations. This can cause the explained symptoms.

Solution: Install *quencharc* (P/N 26676-01) across main contactor(s) coil as described in wiring diagram.

This should alleviate said symptoms.
