Replacing a DIVERSITEC Ballast with a MagneTec Ballast

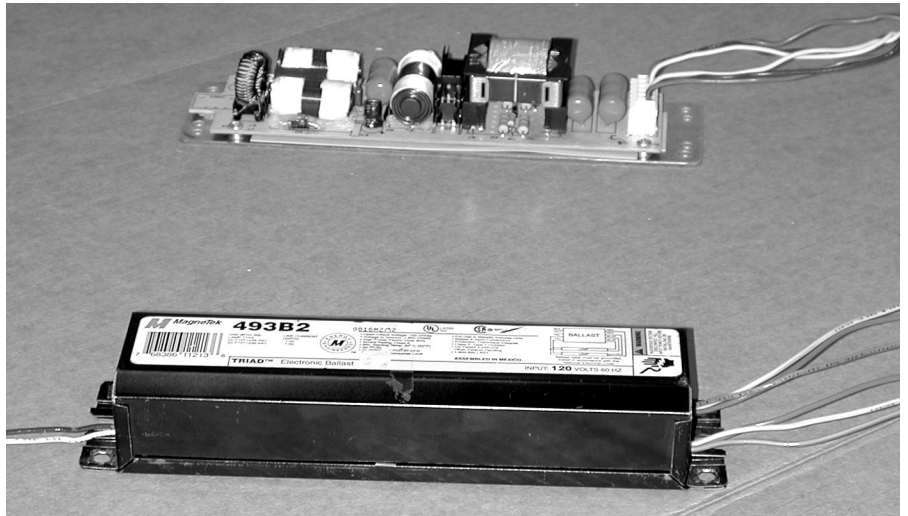
While the two ballasts look different, they are direct replacements for each other. Both have the same number of wires with the same colors.

DIVERSITEC Ballast
(black and white wires missing)

MagneTec Ballast

To begin the replacement, remove the cover from the affected unit. Without disconnecting any wiring, unscrew the affected DIVERSITEC ballast and move it out of the way, by placing it on top of the ballast next to it. Secure the new MagneTec ballast in its place, with the colored wires running in the same direction as the other ballast. Now, one at a time, disconnect a wire and replace it with the new one of the same color. When you have switched all eight wires you are done with the ballast replacement. Reinstall the sunbed cover and any other pieces removed.
