Subject: Excessive Beep Volume

Number: SRV0001

Applicability: SunScape 755
Elite 755

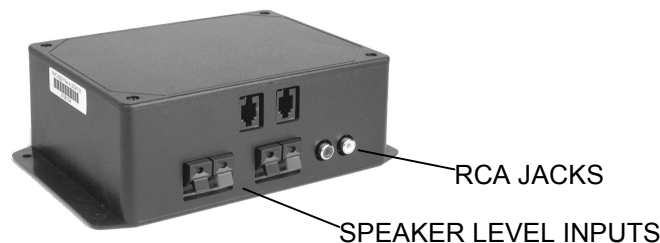
Your sunbed accepts stereo inputs through two types of hook-ups, line level RCA type jacks and speaker level inputs (see illustration below). If possible, use the RCA inputs. Your stereo source must have "Line Level" or "Auxiliary Out" connections similar to the RCA jacks on the black box. Using the RCA inputs eliminates the volume control of the stereo source, allowing the sunbed amplifier more control of the music.

If you must use the speaker level inputs, hook-up the stereo source and turn it on. Apply power to the sunbed. With the stereo source playing, without the sunbed running, adjust the volume of the source to a comfortable level. Do not adjust the volume from the sunbed keypad. This will give you the best sound through the sunbed.
